## **Chapter B**

### **Completions Near San Carlos Reservation**

**TOWNSHIP 3 SOUTH, RANGE 24 EAST, OF THE GILA AND SALT RIVER MERIDIAN, ARIZONA.**

### **Preliminary Statement of the Problem**

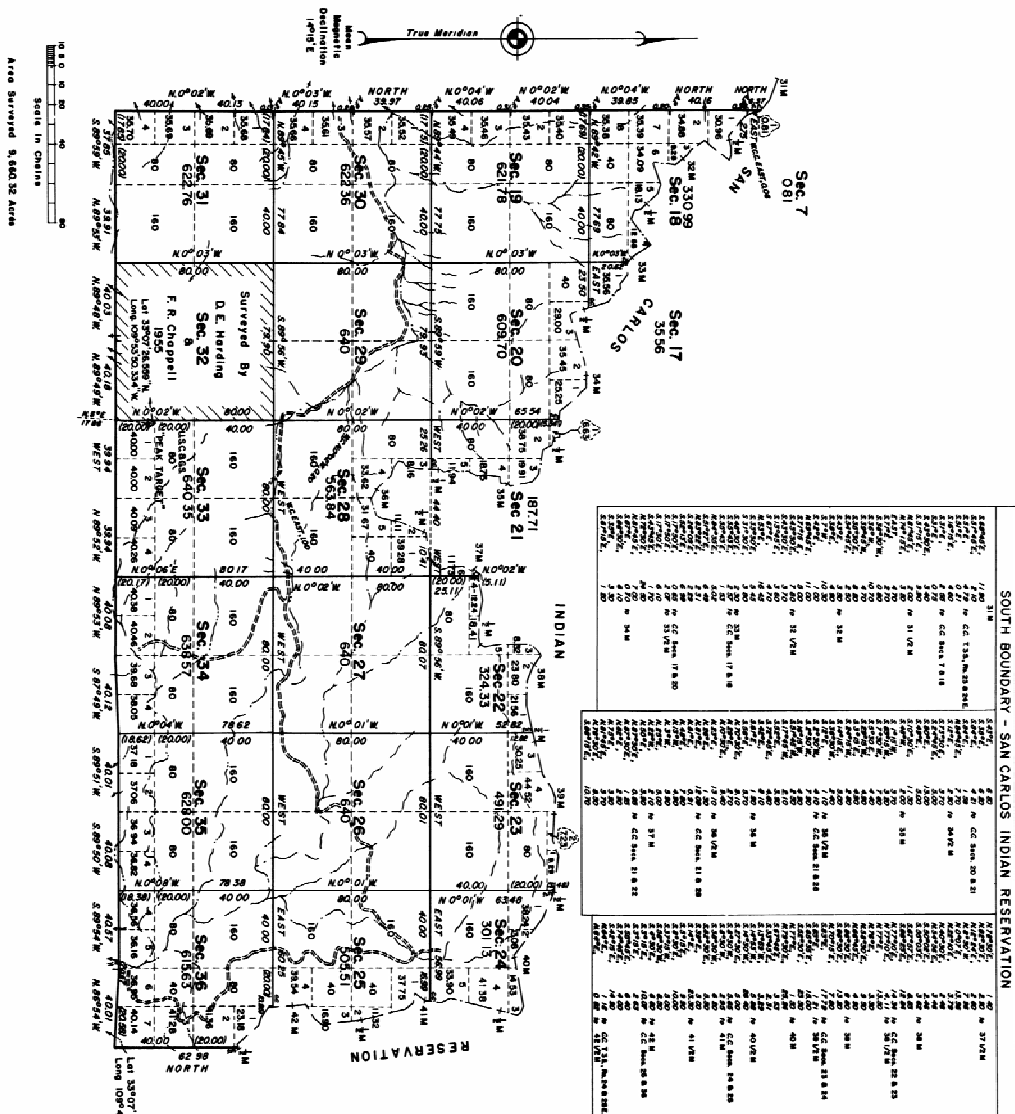
Figure 3 - Accepted Plat

# TOWNSHIP 3 SOUTH, RANGE 24 EAST, OF THE GILA AND SALT RIVER MERIDIAN, ARIZONA. COMPLETION SURVEY

A triangulation station, "Peak Target," was located in section 33. A direct tie was made to that station. From the published geodetic coordinates of this station the latitude and longitude of the southeast corner of the township was computed. The field work was thus completed. The field notes were written and the plat prepared. Figure 3 illustrates the accepted plat.
